Tech Bulletin

XB Upgrade Instructions

This document provides instructions for downloading the latest software version onto a Vesper Marine XB transponder which are currently in stock. This Software version is required to resolve a software issue which might cause the unit to fail to start once “5Hz position updates” has been enabled on the transponder.

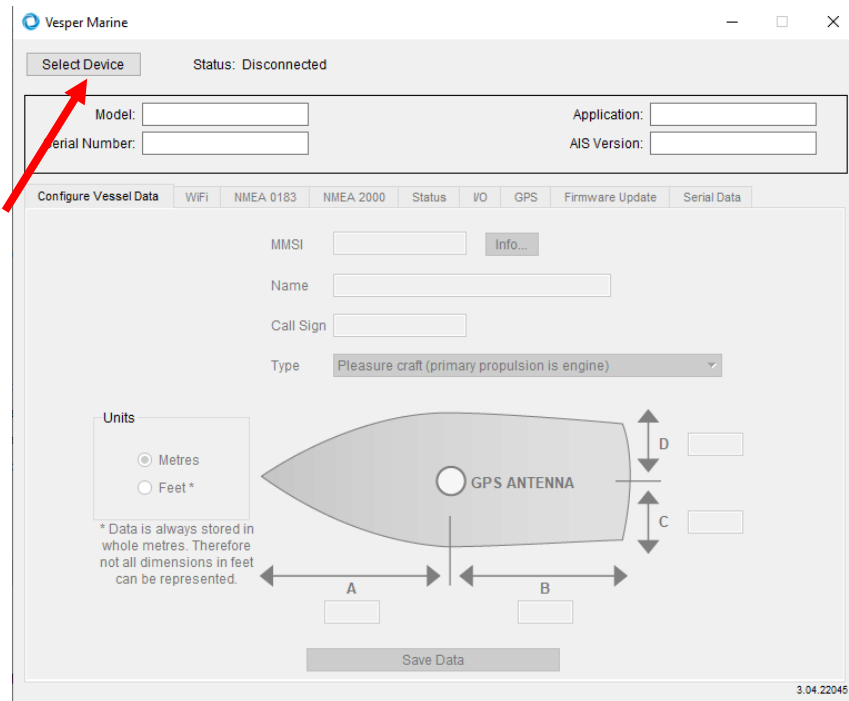
- Connect your PC to the XB8000 / Vision2 via WiFi
- Run the latest version of vmAIS. Download from:
<https://support.vespermarine.com/hc/en-us/articles/360001561976-vmAIS-Configuration-and-Status-Utility>

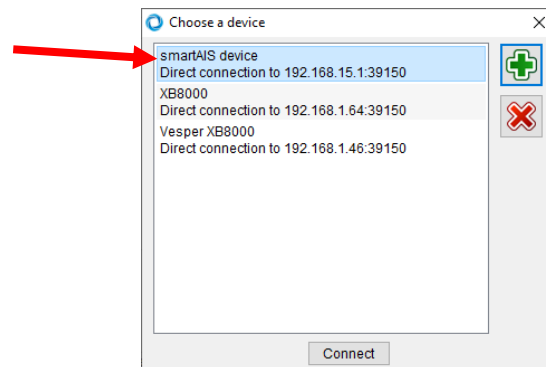
- Click Select Device

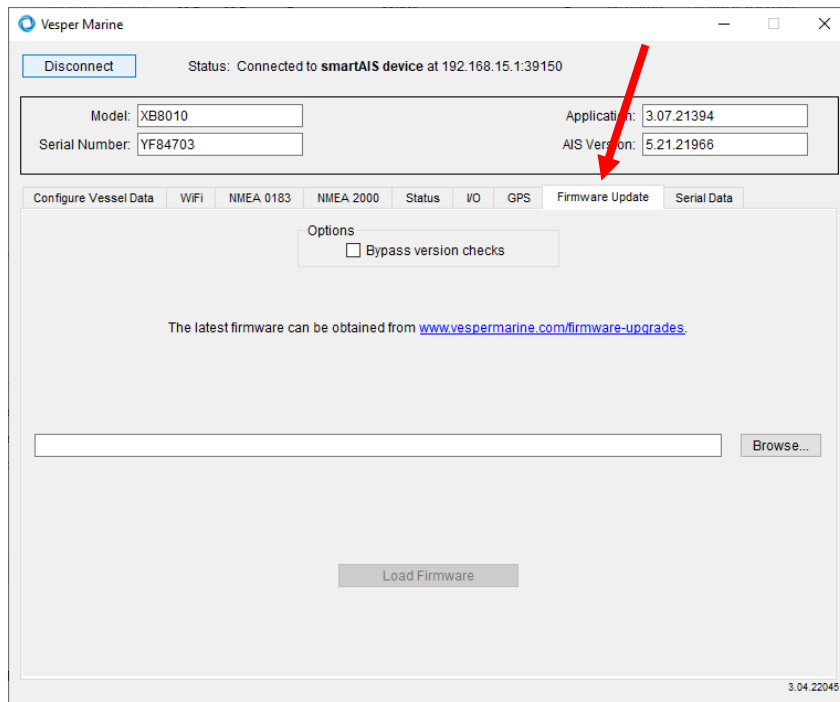
- Choose "Smart AIS device – Direct connection to 192.168.15.1:39150"
- Click Connect
- Click "Firmware Update" tab

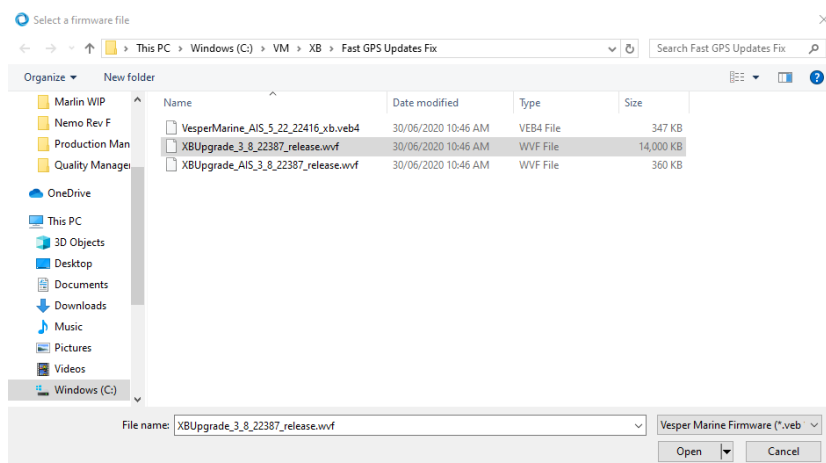
Click “browse”

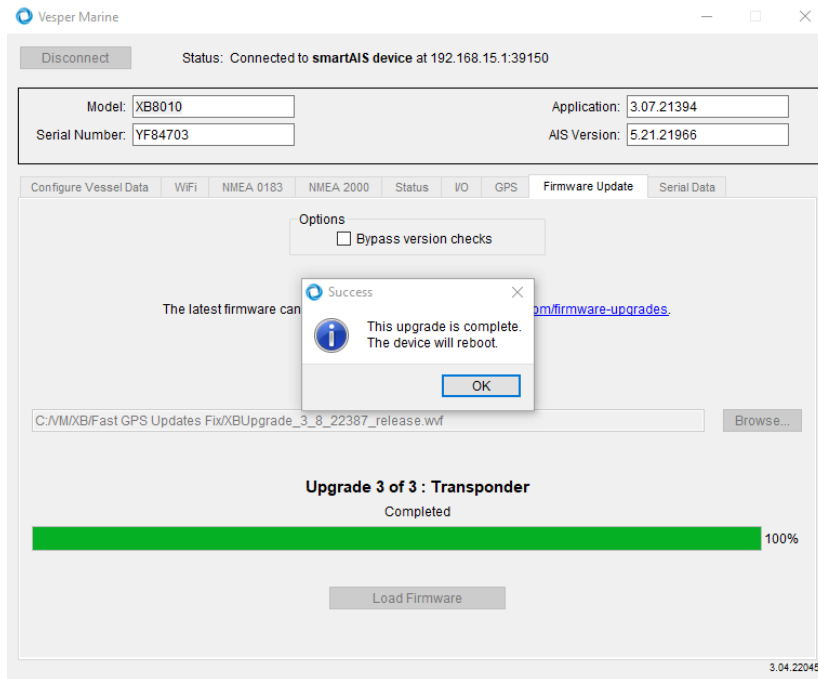
- Select the correct upgrade file:
 - XB8000: **XBUpgrade_AIS_3_8_22387_release.wvf**
 - Vision2: **VisionUpgrade_AIS_3_8_22387_release.wvf**
- Click “Open”
- Click “Load Firmware”, the firmware update will be started (takes +/- 1 minute), you will get a message that the upgrade has been completed.

- Click 'OK' to allow the XB8000 / Vision 2 to reboot
- The transponder has been upgraded successfully.

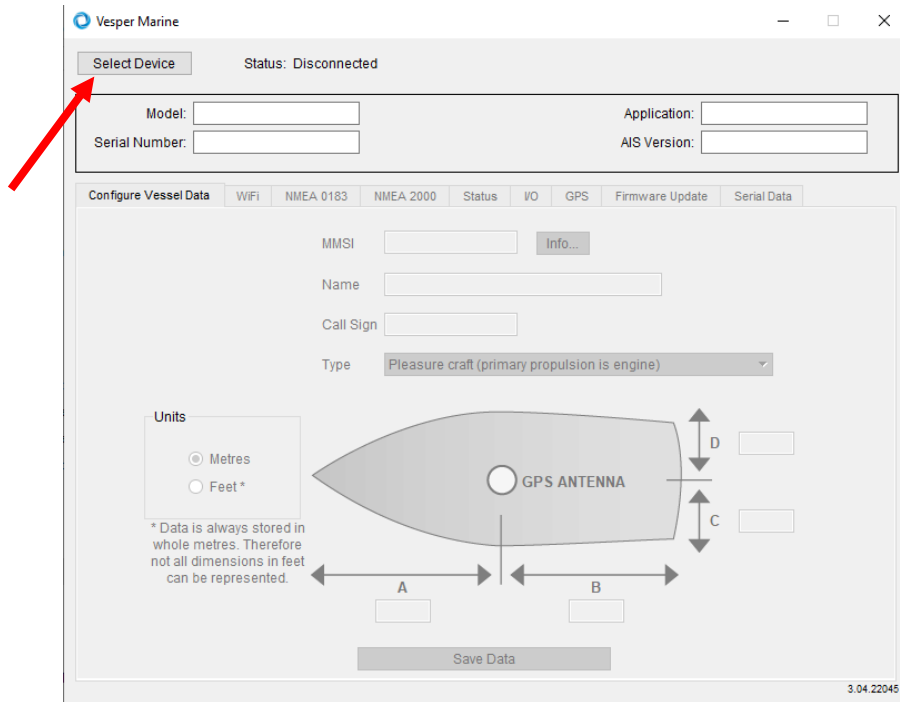
- Connect your PC to the XB6000 via USB
- Run latest version of vmAIS

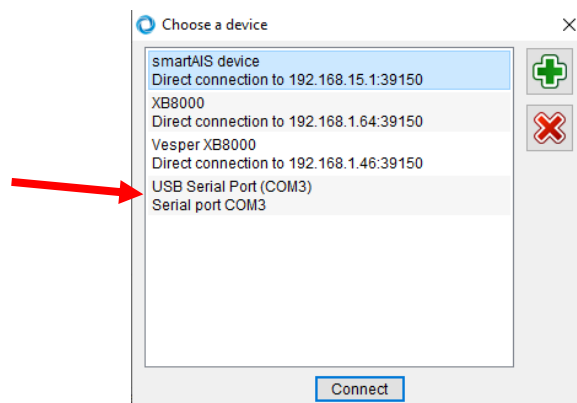
- Click Select Device

- Select the displayed USB Serial Port
- Click "Connect"
- Click "Firmware Update"
- Select the Upgrade file: **VesperMarine_AIS_5_22_22416_xb.veb4**
- Click "Open"
- Click "Load Firmware", the firmware update will be started (takes +/- 1 minute), once done you will get a message that the upgrade has been completed.
- Click "OK" to allow the XB6000 to reboot
- The transponder has been upgraded successfully
